## **Natural Fatigue Crack Initiation and Detection in High Quality Spur Gears**

**ARL-RP-0383**

**June 2012**

*A reprint from the 68<sup>th</sup> American Helicopter Society Annual Form, FT Worth, TX, May 2012.*

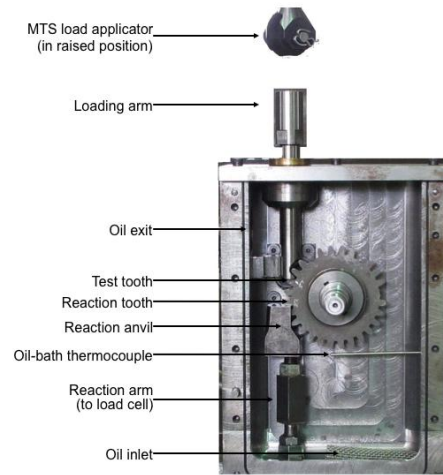
**Figure 1. NASA/ARL Signal Gear-Tooth Bending Test Facility [2].**

The experiments for this paper were conducted using two test rigs at NASA Glenn Research Center. The high-speed Single Gear-Tooth Bending Test Facility was used in order to quickly generate a naturally grown tooth root crack. This facility consists of a 1000 Hz High-Cycle Fatigue Test System produced by the MTS Systems Corporation with a special test head shown in Figure 1. The load arm applies a cyclic load to the test tooth at the highest point of single tooth contact. A reaction tooth, located 2 teeth from the test tooth, counteracts the applied load through the reaction anvil, which contacts the reaction tooth at its root [2]. For ease of discussion, this rig will be referred to as the tooth bending rig for the duration of this paper.

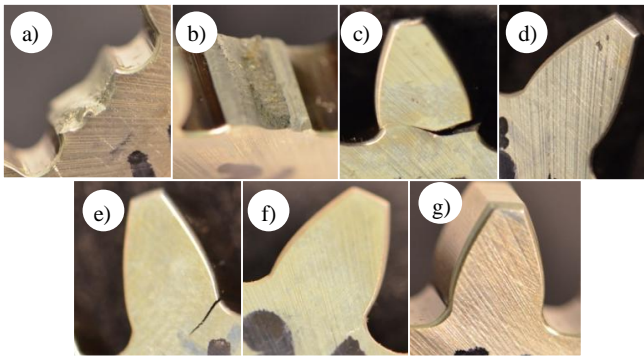
**Figure 3. 1<sup>st</sup> Gear used in the development of a crack initiation methodology. Photos (a-g) represent test teeth 1-7.**

placed back into the rotating rig, but tooth fracture occurred before the rotating fatigue rig reached the set speed. The undamaged teeth on this original specimen were then used to determine a better method for initiating cracks on the tooth bending rig (see Figure 3). After several attempts, it was determined that the most reliable way to generate a tooth crack is to set the initial displacement limit at 2%, manually stopping the rig when a crack is visible. If the displacement limit is reached before crack initiation occurs, the displacement limit is increased and cyclic loading is continued until a crack is visible.

In experiment 1, the initial crack was too large and resulted in tooth failure during the start-up of the rotating fatigue rig. Figure 3 shows the gear after validating the crack-initiation procedure. While no statistical data could be obtained from this experiment, it did yield the methodology for further crack initiation.

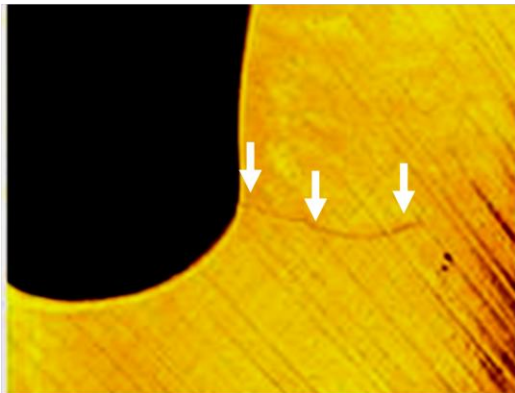
**Figure 4. Cracked tooth after experiment 2.**

The crack generated in experiment 2 is shown in Figure 4. Vibration data, taken during the rotating fatigue rig portion of this test, was processed to obtain the filtered signal averages both before and after crack initiation (Figure 5 (a) and (b)). Filtered signals are created by removing the mesh frequencies and harmonics as well as their first order sidebands from the signal average. The presence of the crack can be seen in Figure 5 (b) at approximately 210 degrees where there is a sudden spike. The frequency spectrum of the signal average before filtering is shown in Figure 5 (c) and (d). The meshing frequency of the test gears can be seen at 28 shaft orders with the first harmonic at 56 shaft orders. Note the increase in the higher order sidebands in the cracked frequency spectrum. These sidebands contribute to the increase in the cracked FM4 CI to 4.5 from a 2.9 baseline and an increase in the M8A CI from 128 to 935.

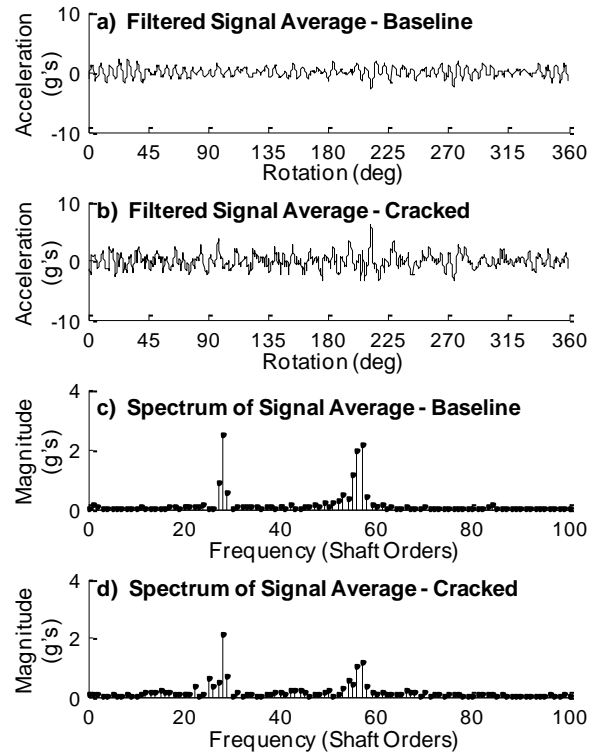
**Figure 5. Experiment 2 results at 7500 RPM and 50 psi.**

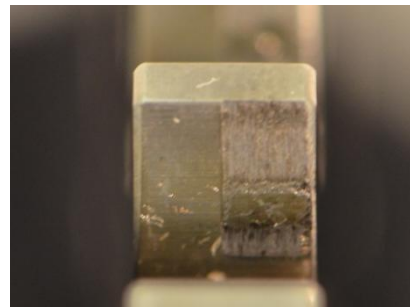
**Figure 6. Pitting damage on test gear after experiment 2.**

The cracked gear in experiment 2 was run for approximately 14.5 hours at increasing speeds and loads and experienced a crack depth increase of only 0.5 mm. While the crack may have been detectable in the data taken during these higher loads and speeds, baseline data was not recorded at these conditions for comparison. After 8 hours, the gear was also offset, changing the contact area to half the facewidth. Visible surface fatigue damage was generated while running at higher loads toward the end of experiment 2. Pitting on this gear set is shown in Figure 6.

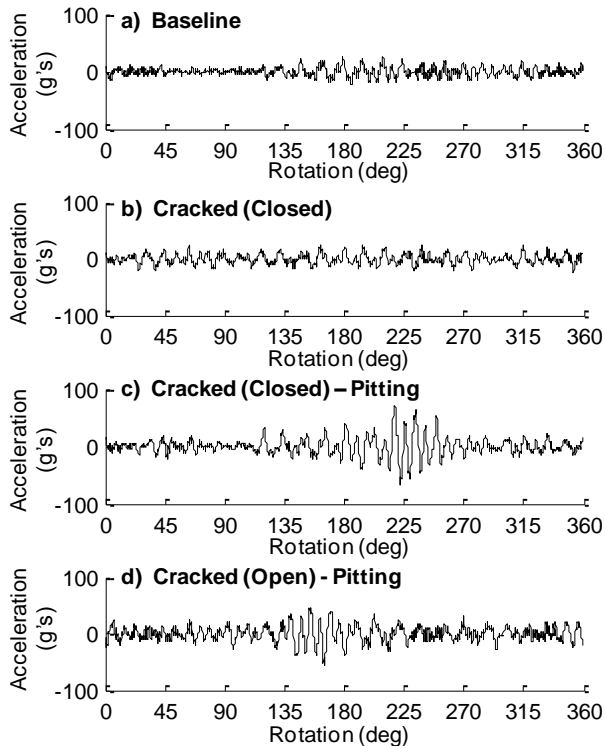
**Figure 7. Filtered signal averages for experiment 3 (10,000 RPM, 400 psi) at several points during the experiment with the crack forced open and closed.**

Figure 7 shows the filtered signal averages at 4 separate points during testing. Figure 7 (a) and (b) show the baseline data and data taken soon after the gear was installed (incorrectly) after crack initiation respectively. Data taken just before flipping the test gear over is shown in Figure 7 (c), with pitting damage expected between 120 and 270 degrees. The mating gear had already incurred pitting damage at this point and was not flipped. Therefore, the pitting damage on the mating gear is visible in the vibration signal taken shortly after reinstalling the test gear in the correct orientation (Figure 7 (d)). This makes crack identification difficult. A CI comparison between data shown in (a) and (d) shows an obvious increase, but would be an indicator of pitting and not the presence of a crack.

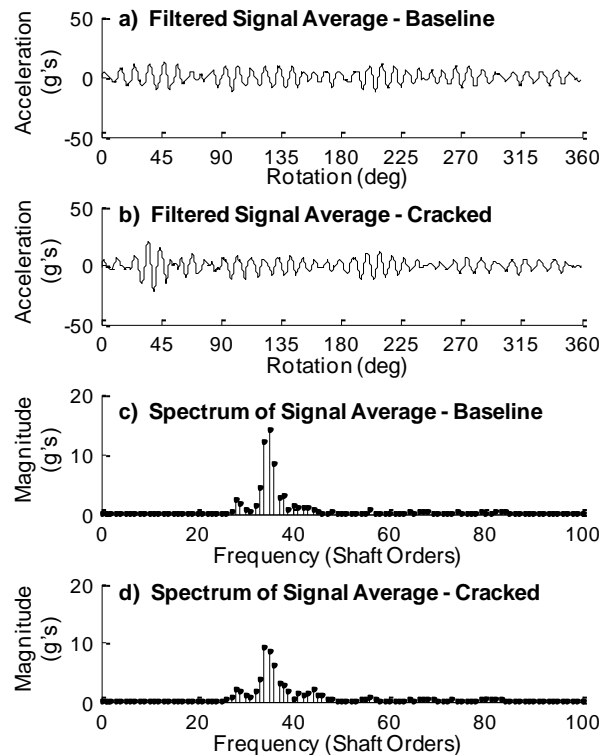
**Figure 8. Experiment 4 results at 7600 RPM and 400 psi load.**

Filtered signal averages are shown in Figure 8 (a) and (b) for experiment 4. This experiment utilized a different PCB accelerometer with a higher frequency range (up to 60 kHz). It was installed, as in the previous experiments, on the bearing housing, however, a different housing was used,

which could account for the different vibration characteristics. The presence of the crack is visible in Figure 8 (b) in the first 45 degrees of rotation. The frequency spectrum of the averaged signal for both the baseline and cracked cases indicates a dominating vibration at approximately 35 shaft orders. This indicates a strong slave gear meshing vibration. Regardless of this resonance, CIs for this particular experiment show a definite increase: 2.2 to 4.2 for FM4 and 23 to 419 for M8A.

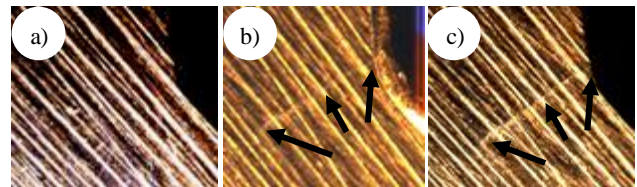
**Figure 9. Test tooth root from experiment 4 before testing (a), after crack initiation (b), and after 70 hours of testing (c).**

After over 70 hours of runtime 7600 RPM and 400 psi load, there was no visible increase in crack depth. This can be seen in Figure 9, which shows the baseline tooth root along with the initialized crack before installation into the rotating rig and crack after 70 hours of runtime.
